# The sinking of the Sleipner A offshore platform

Excerpted from a report of [SINTEF](#), Civil and Environmental Engineering:

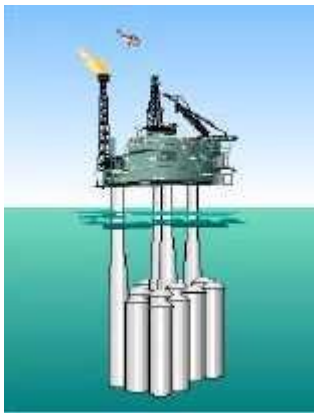
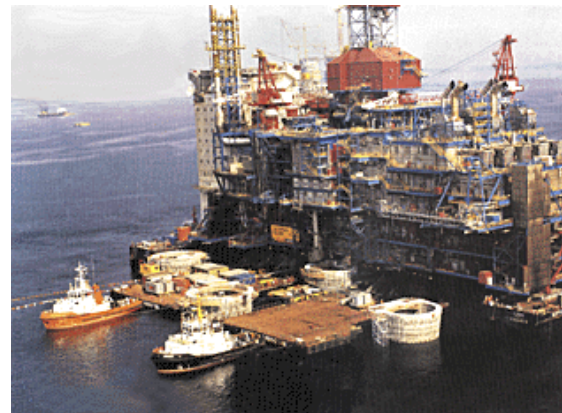
A better idea of what was involved can be obtained from this photo and sketch of the platform. The top deck weighs 57,000 tons, and provides accommodation for about 200 people and

support for drilling equipment weighing about 40,000 tons. When the first model sank in August 1991, the crash caused a seismic event registering 3.0 on the Richter scale, and left nothing but a pile of debris at 220m of depth. The failure involved a total economic loss of about \$700 million.

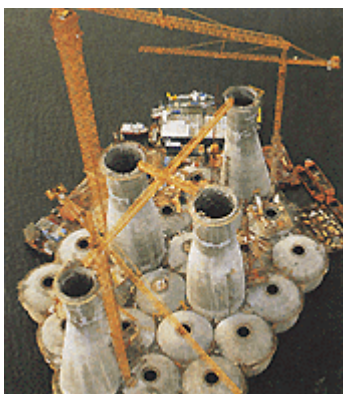
The 24 cells and 4 shafts referred to above are shown to the left while at the sea surface. The cells are 12m in diameter. The cell wall failure was traced to a tricell, a triangular concrete frame placed where the cells meet, as indicated in the diagram below. To the right of the diagram is pictured a portion of tricell undergoing failure testing.

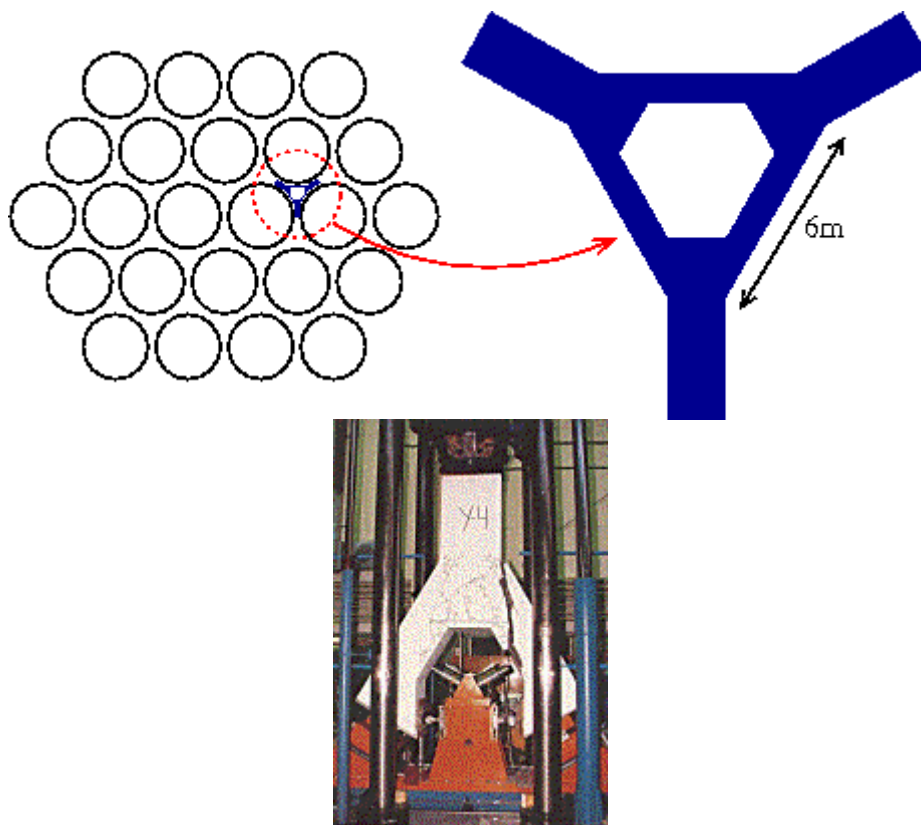
The post accident investigation traced the error to inaccurate finite element approximation of the linear elastic model of the tricell (using the popular finite element program NASTRAN). The shear stresses were underestimated by 47%, leading to insufficient design. In particular, certain concrete walls were not thick enough. More careful finite element analysis, made after the accident, predicted that failure would occur with this design at a depth of 62m, which matches well with the actual occurrence at 65m.
